CAPE GEORGE COLONY CLUB MARINA RESERVES

Port Townsend, Washington

STANDARD
LEVEL 2 RESERVE STUDY UPDATE WITH A SITE VISIT
With funding recommendations for the fiscal year ending 2018

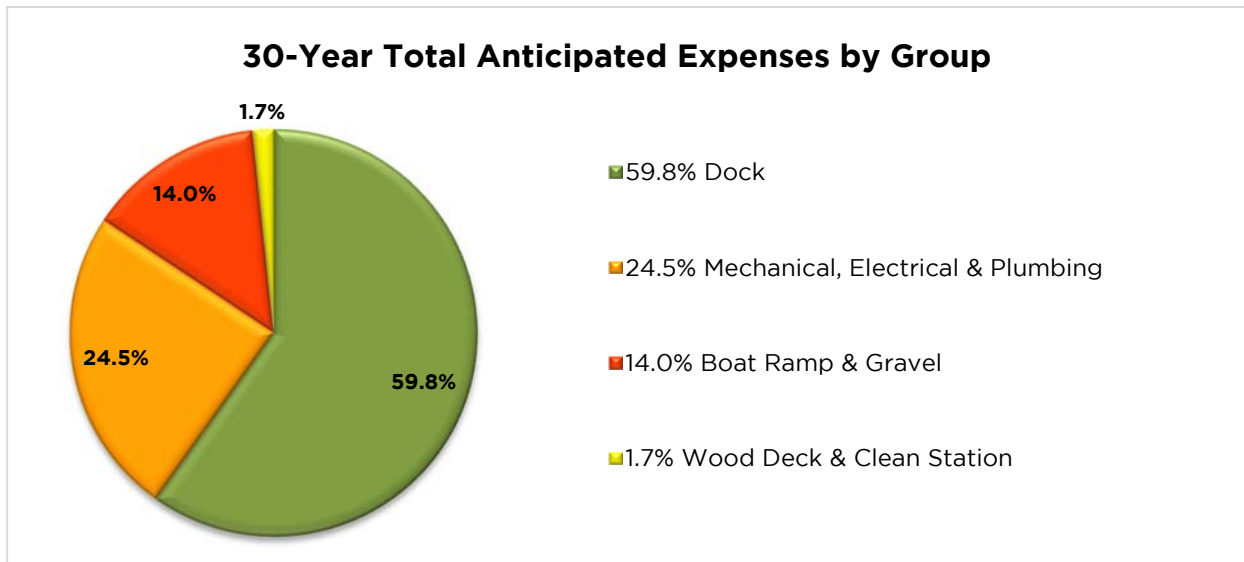
Projected Major Repair or Replacement Expenses Over the Next 30 Years

The following illustrates anticipated major repair or replacement expenses over the next 30 years. Changing the timing or costs of these items may result in changes to the recommended contribution. Independent design specifications and oversight are suggested for repairs to the building envelope. We further recommend that the planning stages for these repairs start at least one year before the estimated repair to obtain a scope of repair, select and schedule a contractor, and secure financing for the project.

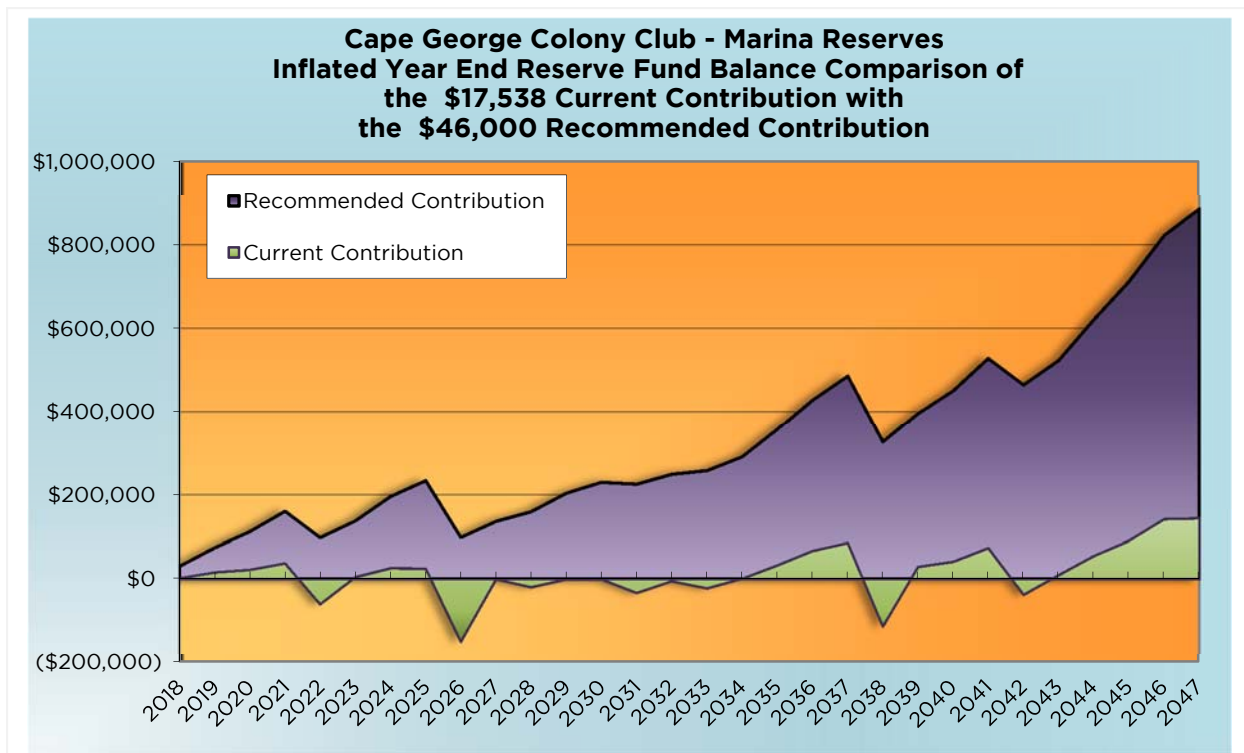
Below is a graph illustrating the projected year end reserve fund balance using both the current budgeted annual contribution and the recommended funding. The graph includes the anticipated adjustment in the reserve contribution starting in 2030.

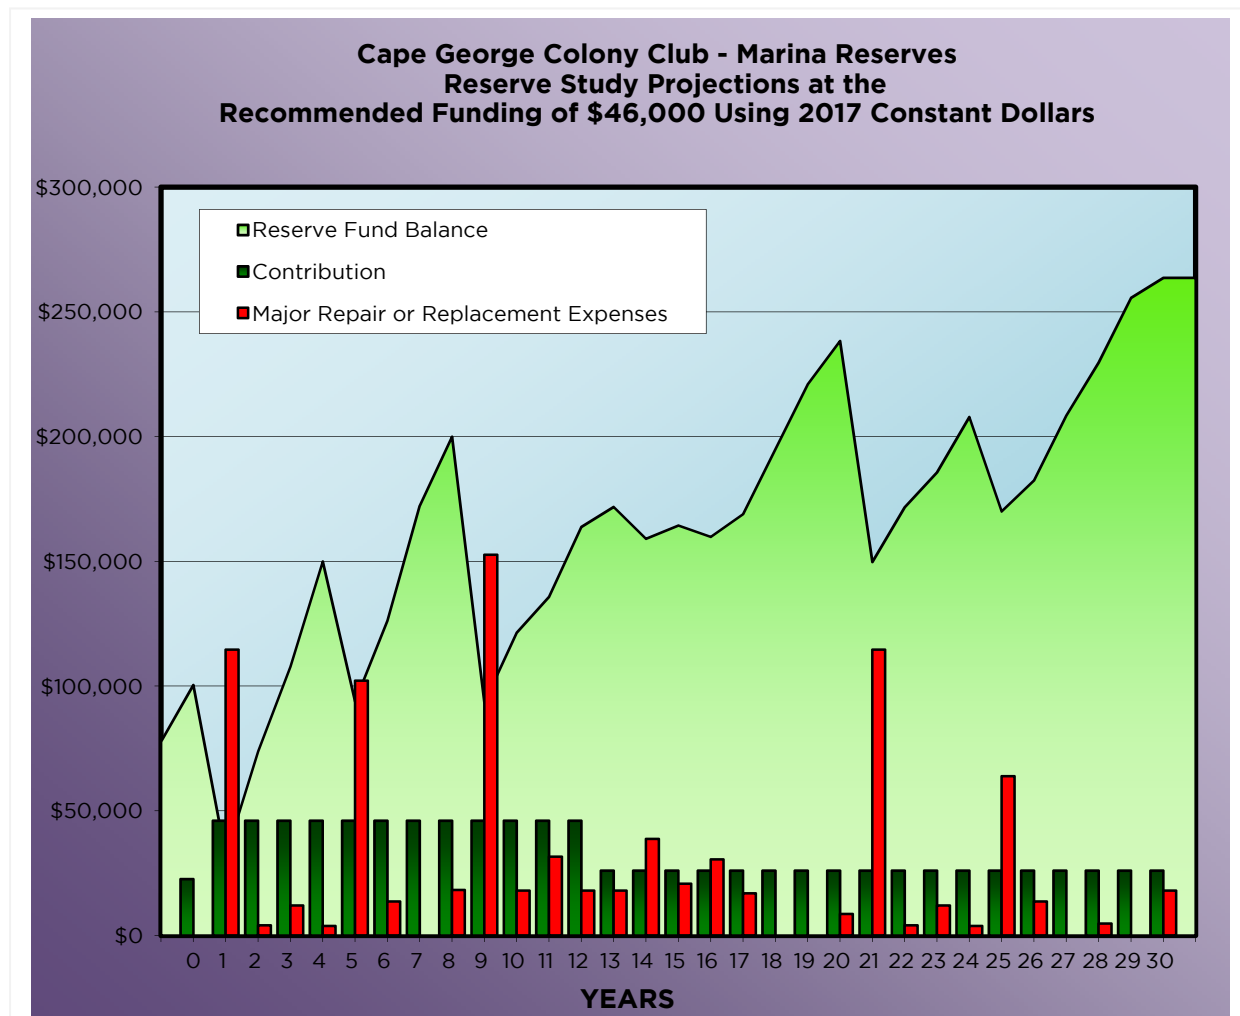
**Reserve Study Projections at the Starting Recommended Funding of \$46,000
Using Constant Dollar Values**

The annual reserve fund contributions are shown as green bars. This chart depicts the annual contribution in constant dollars, so the contributions are constantly \$46,000 over the 30 year timeline of the study, with exception of the anticipated contribution adjustment in 2030.

The anticipated yearly major repair or replacement expenses are shown as red bars, clearly illustrating the anticipated expenses over the next 30 years.

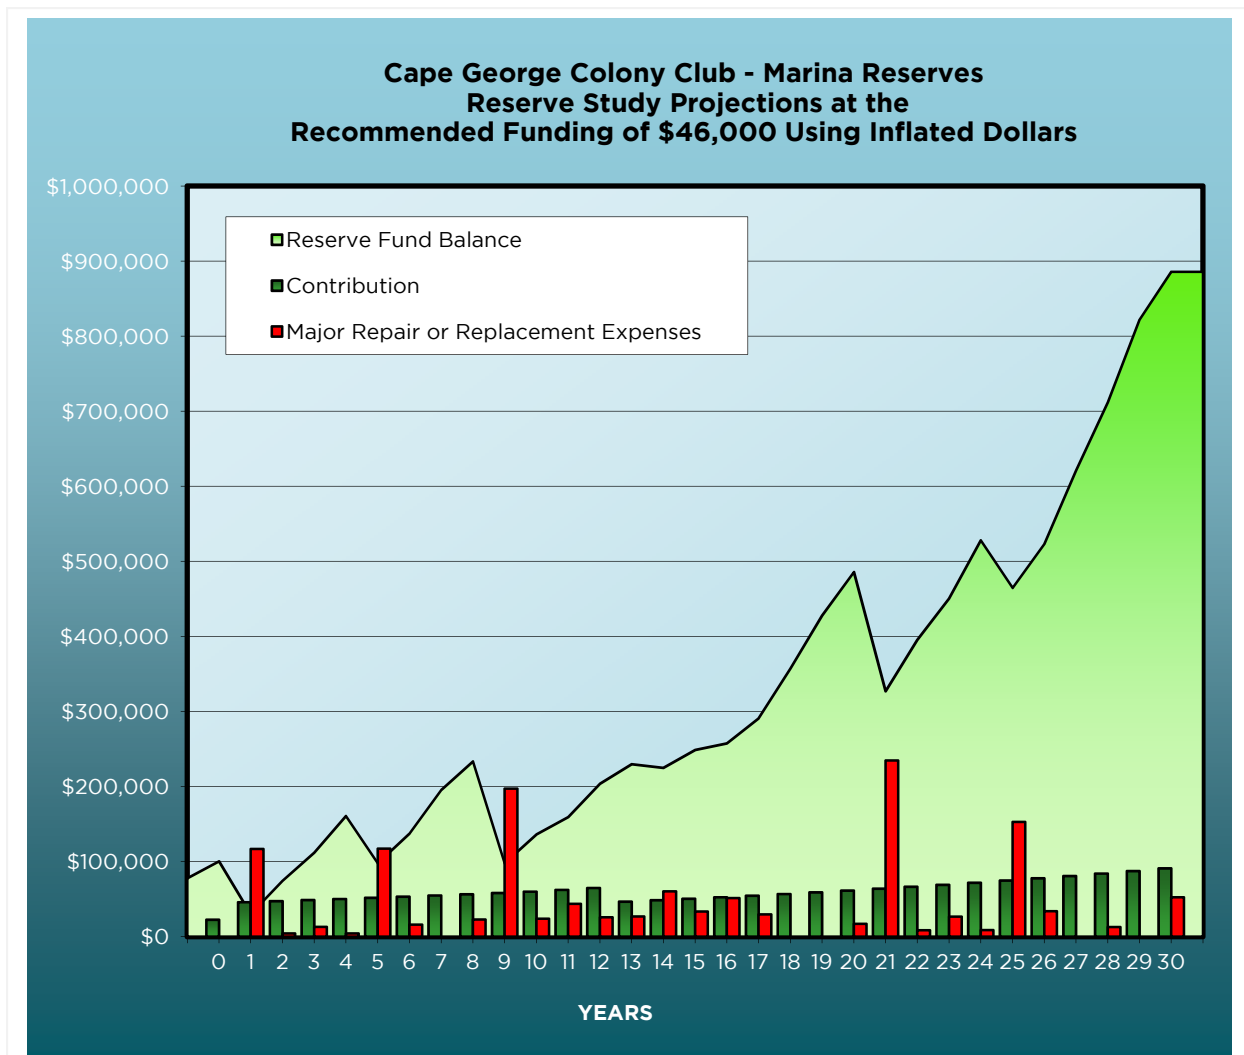
**Reserve Study Projections at the Starting Recommended Funding of \$46,000
Using Inflated Dollar Values**

The annual reserve fund contributions are shown as green bars. This chart depicts the annual contribution inflated each year, so the contributions gradually increase over the 30 year timeline of the study from the initial contribution of \$46,000, with exception of the anticipated contribution adjustment in 2030.

The anticipated yearly major repair or replacement expenses are shown as red bars, clearly illustrating the anticipated expenses over the next 30 years.

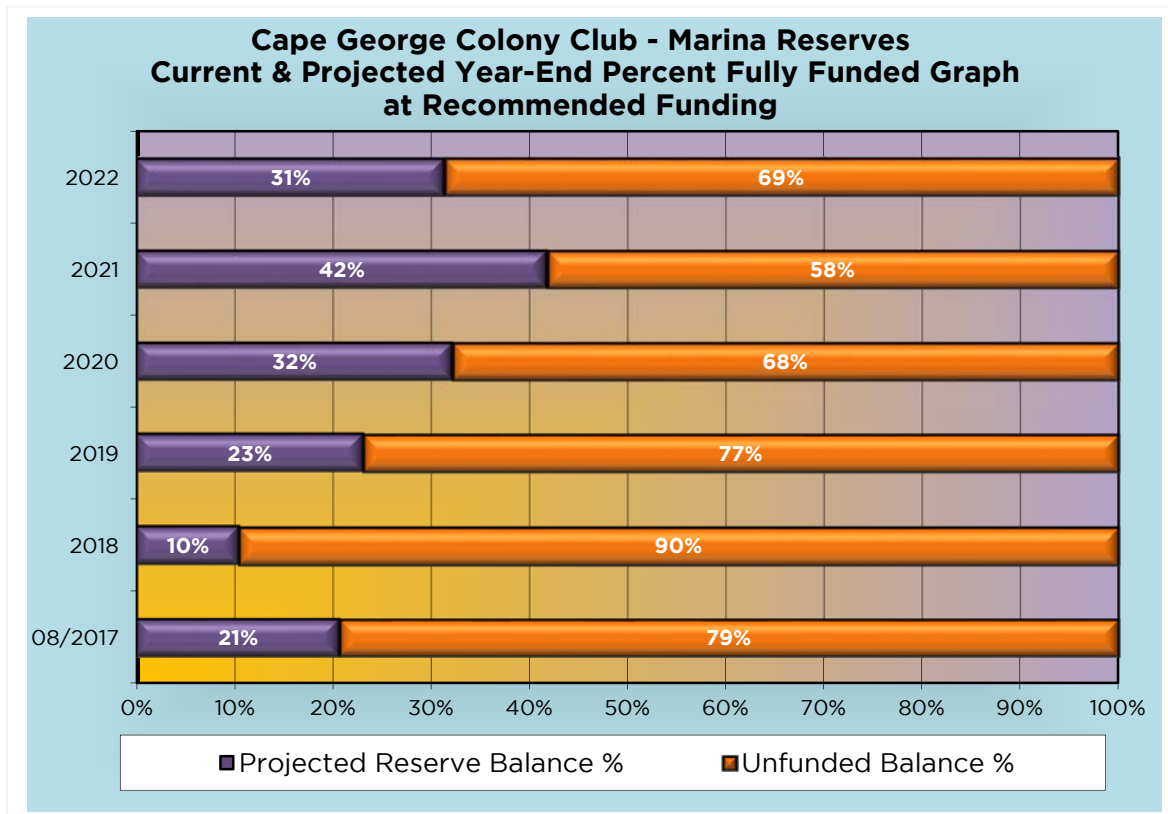
Below is a graph with the current and projected year-end percent fully funded calculated at the recommended starting annual reserve contribution of \$46,000.

The following chart illustrates the projected percent funded at year end over the next 30 years at the recommended starting contribution rate of \$46,000. The values include interest and inflation rate assumptions, and the anticipated contribution adjustment in 2030.

At 21%, Cape George Colony Club is considered at high risk for special assessment.
